Innecity Building
Rehabilitation

Project Profile

Waterproofing Solution for Building Rehabilitation Works

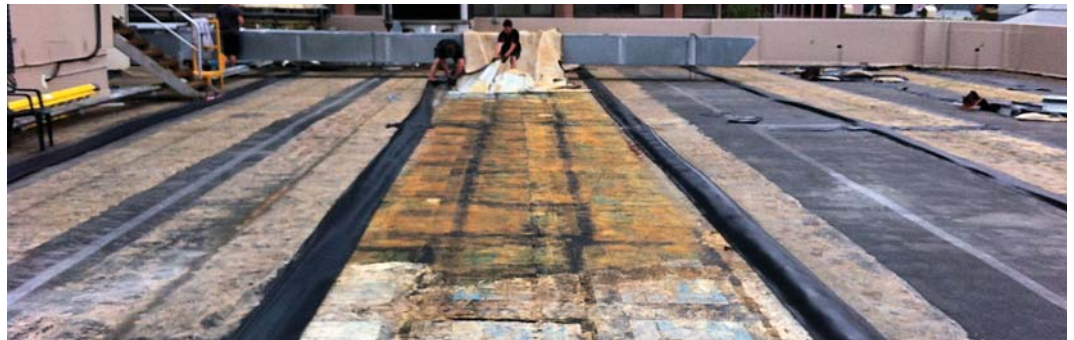
Removal of the synthetic grass covering the rooftop, and the loose-laid PVC waterproofing membrane 'blanket' beneath the grass layer, exposed an additional two layers of torch-on waterproofing membrane which, by its appearance, had been applied in a 'patch by patch' manner over a number of years. Cutting away the torch-on membrane exposed what was to be the biggest issue of all – the fact that all of the layers had been installed onto a screed layer which was now covered with stagnant water and covered with mould.

The only solution was to remove all of the layers, strip the roof right back and 'start from scratch' - stripping the roof off to the base slab, removing all of the existing membranes and coatings, and then waterproof the roof using the high performance Coniroof 2160 waterproofing system from BASF.
