What Lies BENEATH

Sometimes the biggest problems are the ones you can't see

➤ Leaking rooftop uncovers a long history of sub-standard waterproofing applications

➤ Inner-city building repair exposes unintended consequences of previous repair attempts

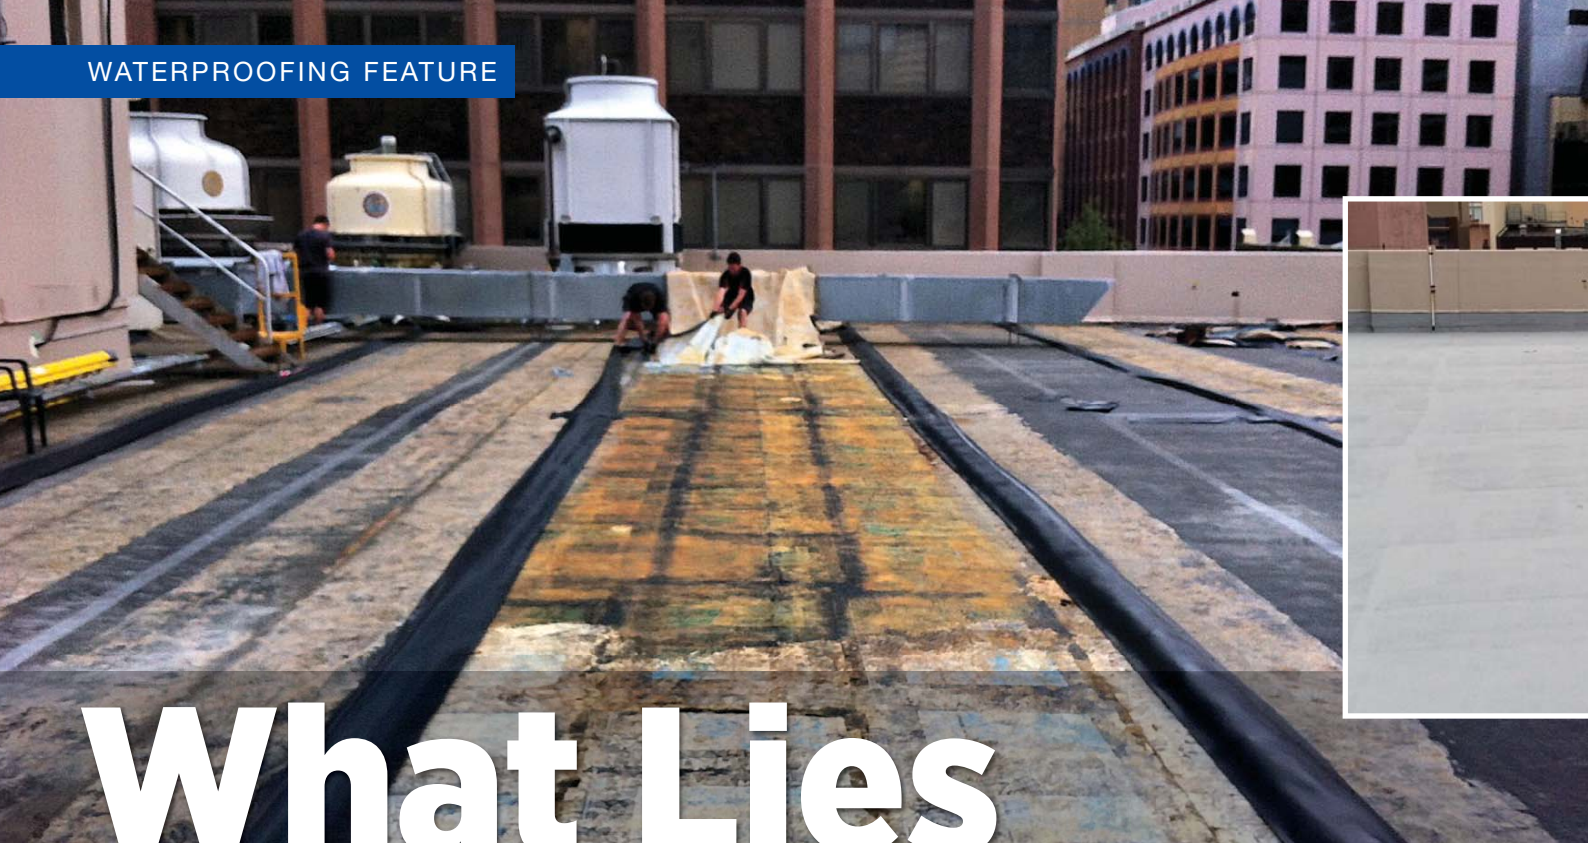
Removal of the synthetic grass and the loose-laid PVC waterproofing membrane 'blanket' beneath the grass layer exposed an additional two layers of torch-on water proofing membrane which, by its appearance, had been applied in a 'patch by patch' manner over a number of years.

Unfortunately, cutting away the torch-on membrane exposed what was to be the biggest issue of all – the fact that all of the layers had been installed onto a screed layer which was now covered with stagnant water and covered with mould. With this discovery, the decision was made to strip the roof off to the base slab, removing all of the existing membranes and coatings, and then waterproof the roof using the high performance Coniroof® 2160 waterproofing system from BASF.

Following the removal of all of the old waterproofing materials, the roof surface was prepared using a combination of shot blasting and grinding. The prepared exposed roof surface was then left to dry thoroughly, with moisture testing carried out to ensure that it dried sufficiently.

Surface faults, cracks and other damage was repaired prior to the application of two primer coats of Concessive® 2525, the first with a sand cast and the second with no sand. Concessive® 2525 is a solvent free

epoxy binder and structural adhesive which forms the base / primer layer for the Coniroof® 2160 system. This was followed by a 2mm thick trowel application, and a subsequent 1mm thick application of Conipur® M860 - a solvent free, two-component, self-levelling, polyurethane based, elastomeric coating.

The final stages of the waterproofing project incorporated a roller-applied layer of Conipur® TC 459 top coat with a sand cast to aid with slip resistance, and then a final layer of Conipur® TC 459 top coat without sand.
